# Manhole Inspection Summary

Manhole # S27CC\_017MH

Insp Date: **6/29/09 1:20 PM**

**Location** Address: **551 LAFAYETTE AVE**

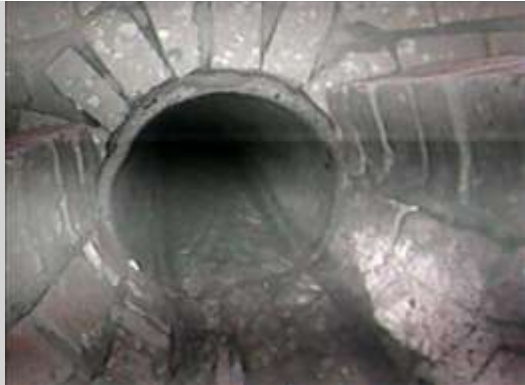
12 O'Clock Outflow

10 in. Circular Gravity Sewer  
Pipe Out @ 12 O'Clock

Pipe Height: (in.) Direct  
Pipe Material: **Clay** ☐ Pipe Lined  
Invert Depth: **19.20** (ft.) Flow Characteristics: **Slow**  
Deposits: ☒ None ☐ Mud ☐ Sludge ☐ Debris ☐ Grease  
Silt Depth: (in.) Deposits Extent:  
Infiltration: **None** Pipe Seal Cond: **Sound**

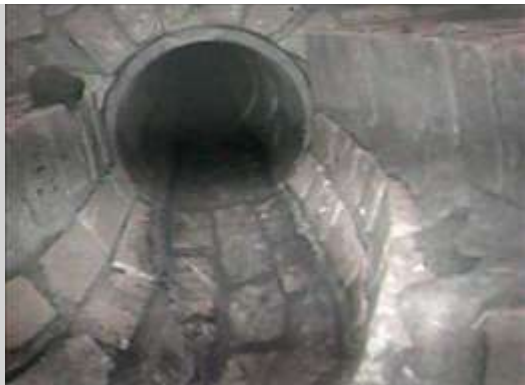
3 O'Clock Inflow

21 in. Circular Gravity Sewer  
Pipe In @ 3 O'Clock

Pipe Height: (in.) Direct  
Pipe Material: **Clay** ☐ Pipe Lined  
Invert Depth: **9.12** (ft.) Flow Characteristics: **Slow**  
Deposits: ☒ None ☐ Mud ☐ Sludge ☐ Debris ☐ Grease  
Silt Depth: (in.) Deposits Extent:  
Infiltration: **None** Pipe Seal Cond: **Sound**

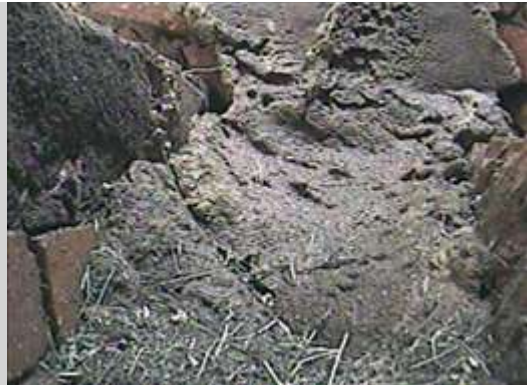
7 O'Clock Inflow

CLOGGED CEMENTED OVER

Invert Depth: **8.57** (ft.) Flow Characteristics: **None**

Connects To: **Stub connection / abandoned**

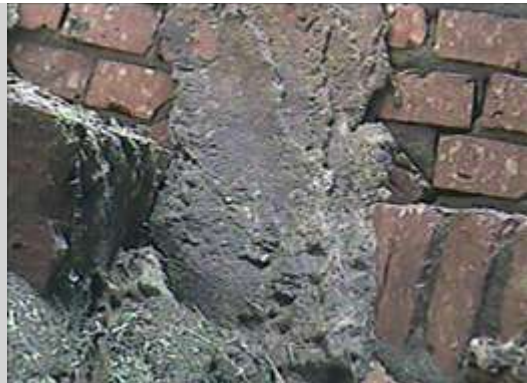
9 O'Clock Inflow

CLOGGED CEMENTED OVER

Invert Depth: **8.65** (ft.) Flow Characteristics: **None**

Connects To: **Stub connection / abandoned**
